Manhole Inspection Summary

Manhole # S01UU1016MH

Record Plat: **01UU1** Node: **016** Status: **Paragraph 8 - New Manholes** Insp Date: **7/31/06 7:04 AM**

Location Address: **3714 Menlo Dr**

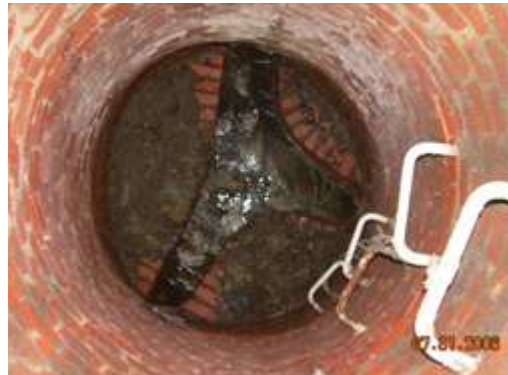
Top View

Infiltration: ☐ None ☐ Joint ☐ Cracks ☐ Mortar ☐ Roots ☒ **Wall**

Condition: ☐ Sound ☐ Cracked ☐ Root Intrusion ☐ Deteriorated ☐ Leaks ☒ **Debris**

☒ **Evidence Of Surcharge** Depth: **1** (ft.) ☐ Active Surcharge Present

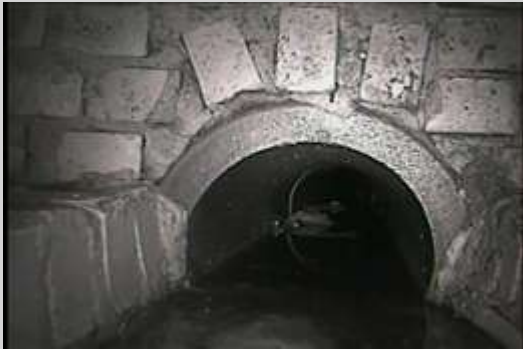
10 in. Circular Gravity Sewer Pipe Out @ 12 O'Clock

Deposits: ☐ None ☐ Mud ☐ Sludge ☒ **Debris** ☐ Grease

Silt Depth: **0.5** (in.) Deposits Extent: **Medium**

Infiltration: **None** Pipe Seal Cond: **Sound**

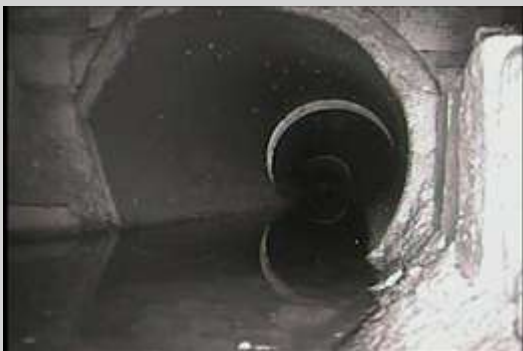
8 in. Circular Gravity Sewer Pipe In @ 3 O'Clock

Deposits: ☐ None ☐ Mud ☐ Sludge ☒ **Debris** ☐ Grease

Silt Depth: **0.5** (in.) Deposits Extent: **Medium**

Infiltration: **None** Pipe Seal Cond: **Sound**

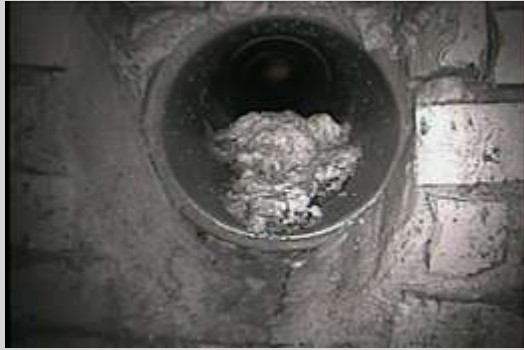
8 in. Circular Gravity Sewer

Deposits: ☐ None ☐ Mud ☐ Sludge ☒ **Debris** ☐ Grease

Silt Depth: **0.25** (in.) Deposits Extent: **Medium**

Infiltration: **None**

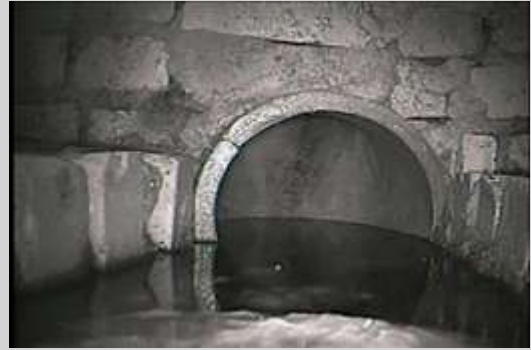
Drop In @ 6 O'Clock

Drop: **Outside** Rod and Bar

Reading: **10.49** (ft.)

Inv Depth: **11.49** (ft.)

Drop Condition: **Open**
